3-YEAR ASBESTOS RE-INSPECTION REPORT

NEIL ARMSTRONG ELEMENTARY SCHOOL SCRANTON, PA

**SCRANTON SCHOOL DISTRICT
425 North Washington Avenue
Scranton, Pa. 18505**

PROJECT: #SSD.19_751

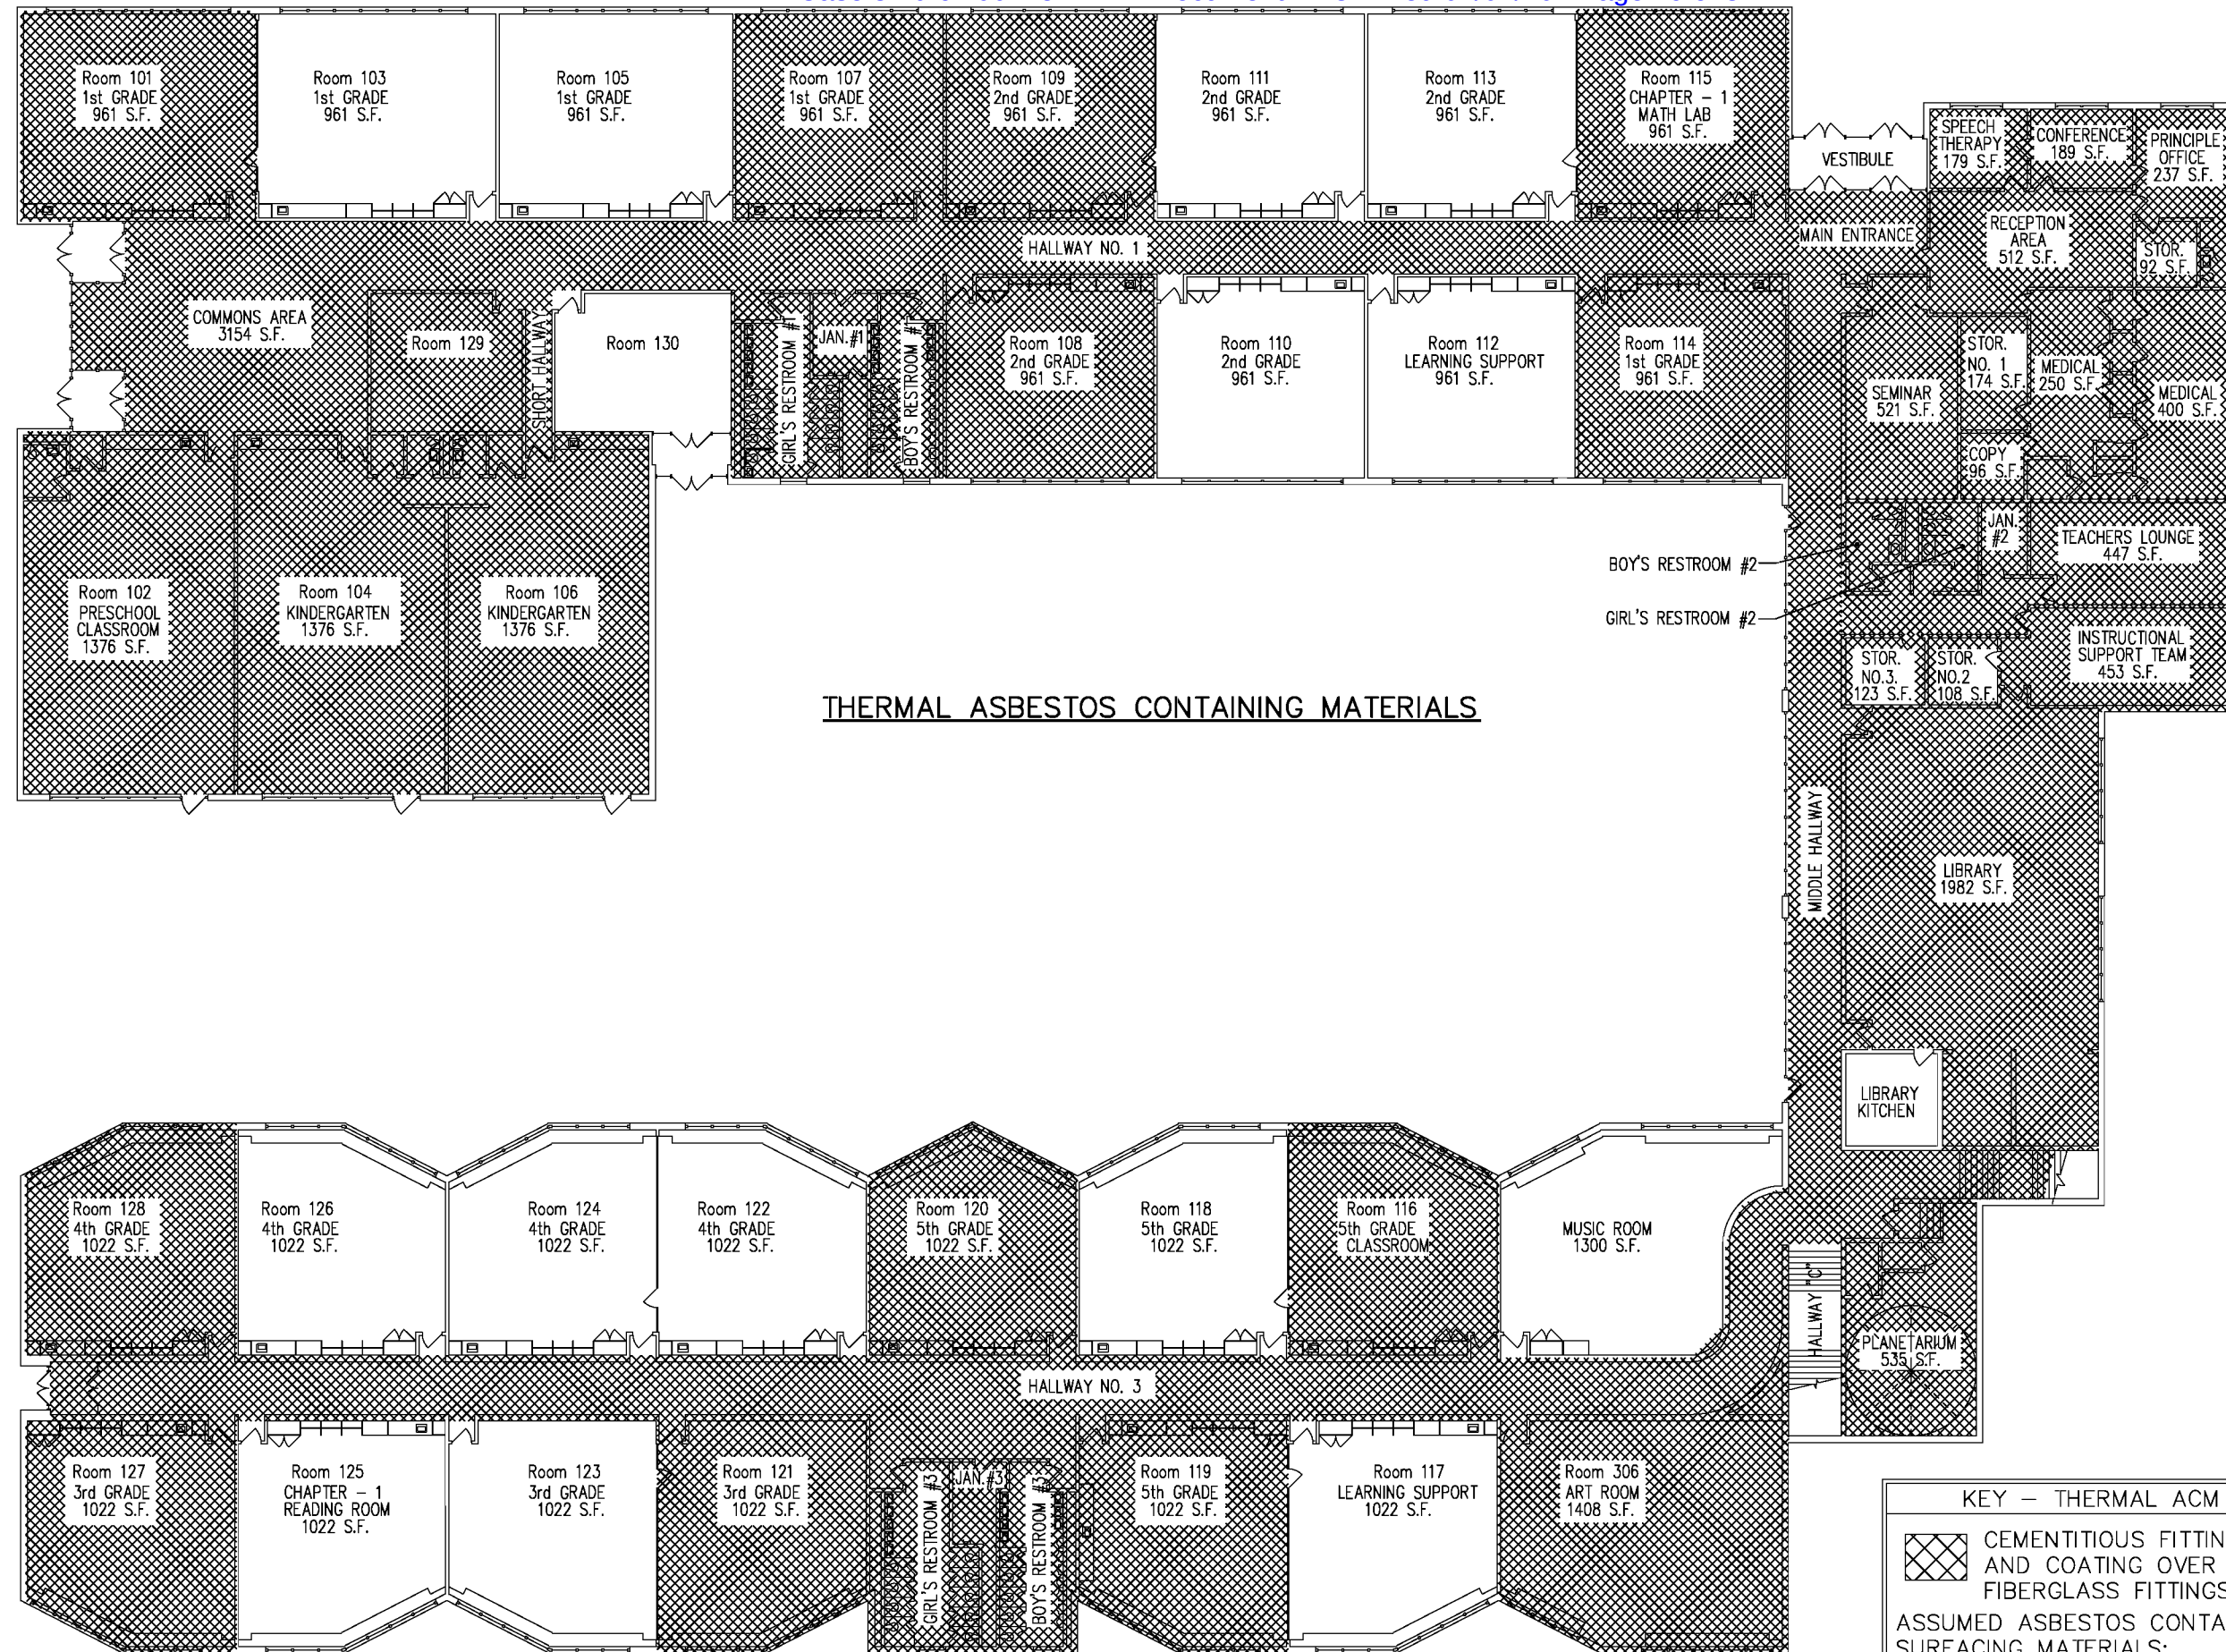
DRAWING No.: **A3**

THERMAL ASBESTOS CONTAINING MATERIALS

- CEMENTITIOUS FITTINGS AND COATING OVER FIBERGLASS FITTINGS
- ASSUMED ASBESTOS CONTAINING SURFACING MATERIALS:
- 1. GASKETS ON BOILER

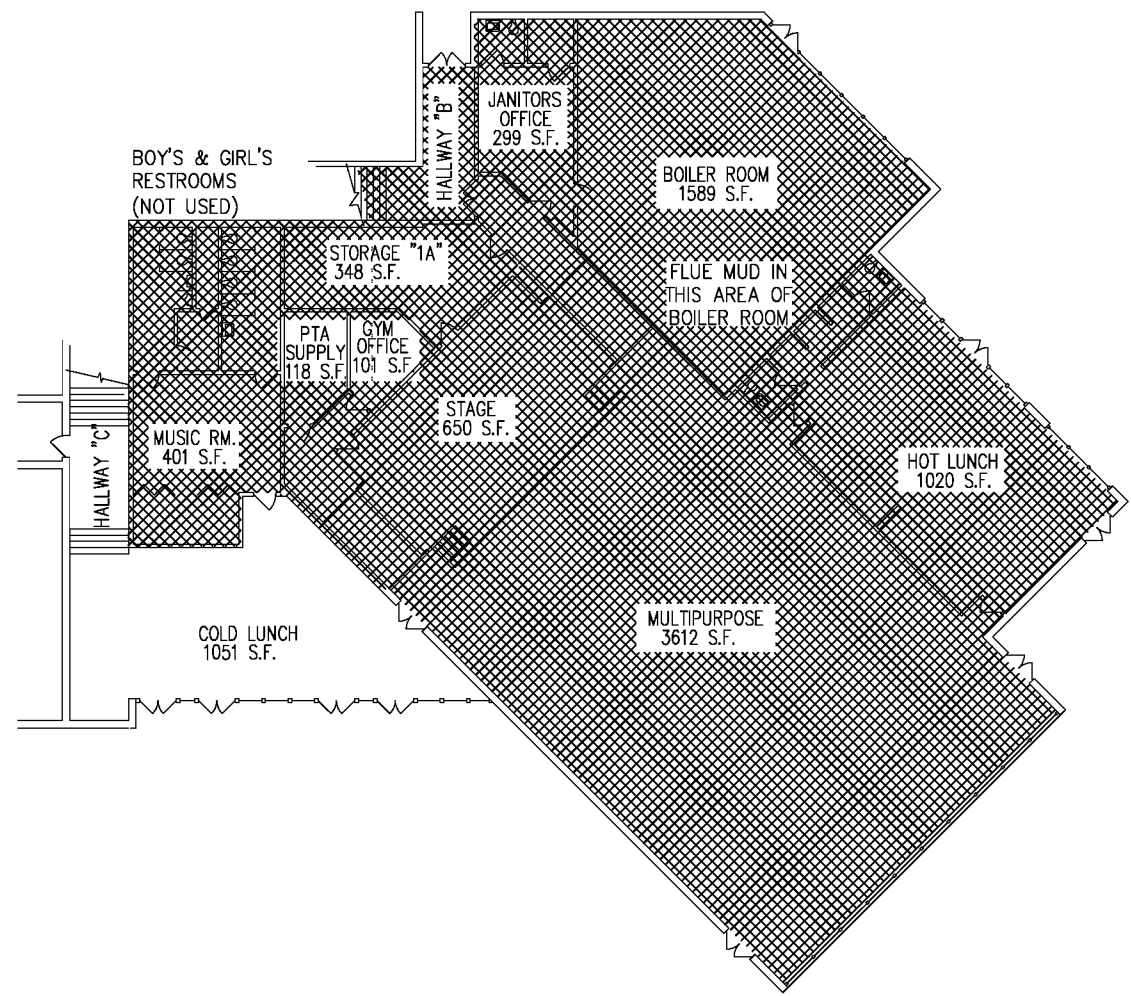
DRAWING No.:
A
4

THERMAL ASBESTOS CONTAINING MATERIALS

CEMENTITIOUS FITTINGS AND COATING OVER FIBERGLASS FITTINGS

NOTE: ROOF DRAIN FITTINGS MAY EXIST ABOVE GYM CEILING

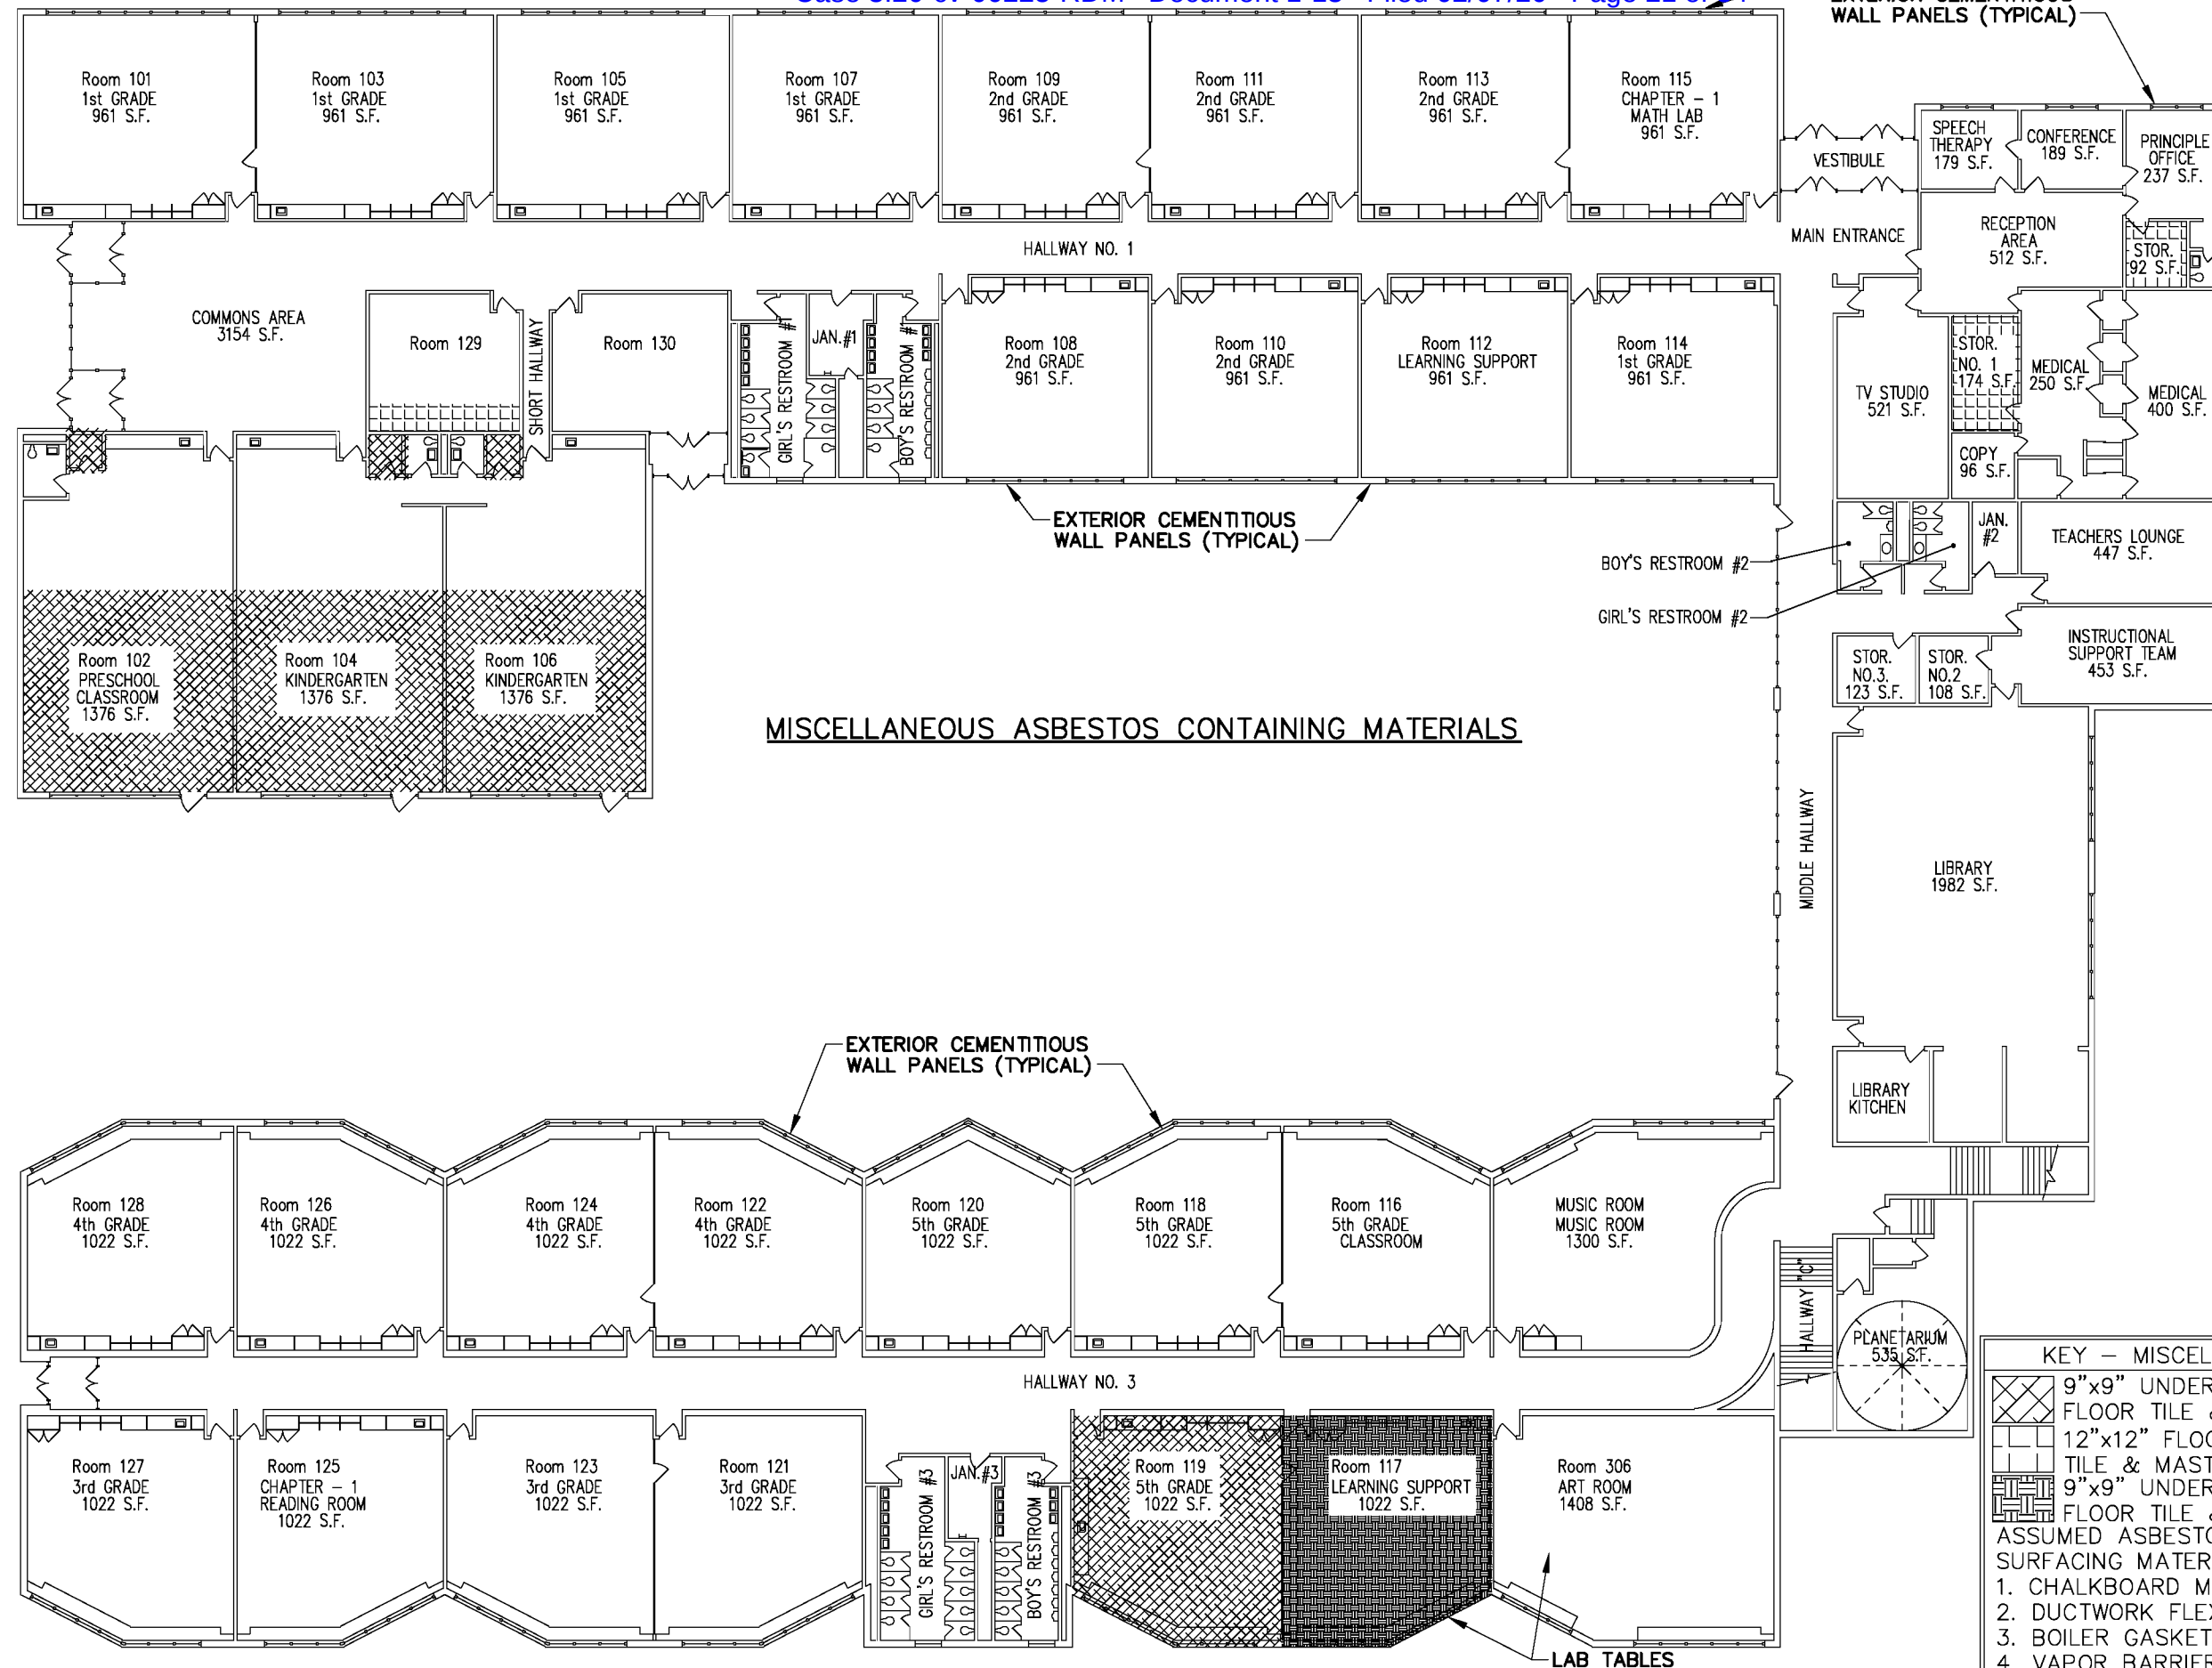
DRAWING No.:
A5

MISCELLANEOUS ASBESTOS CONTAINING MATERIALS

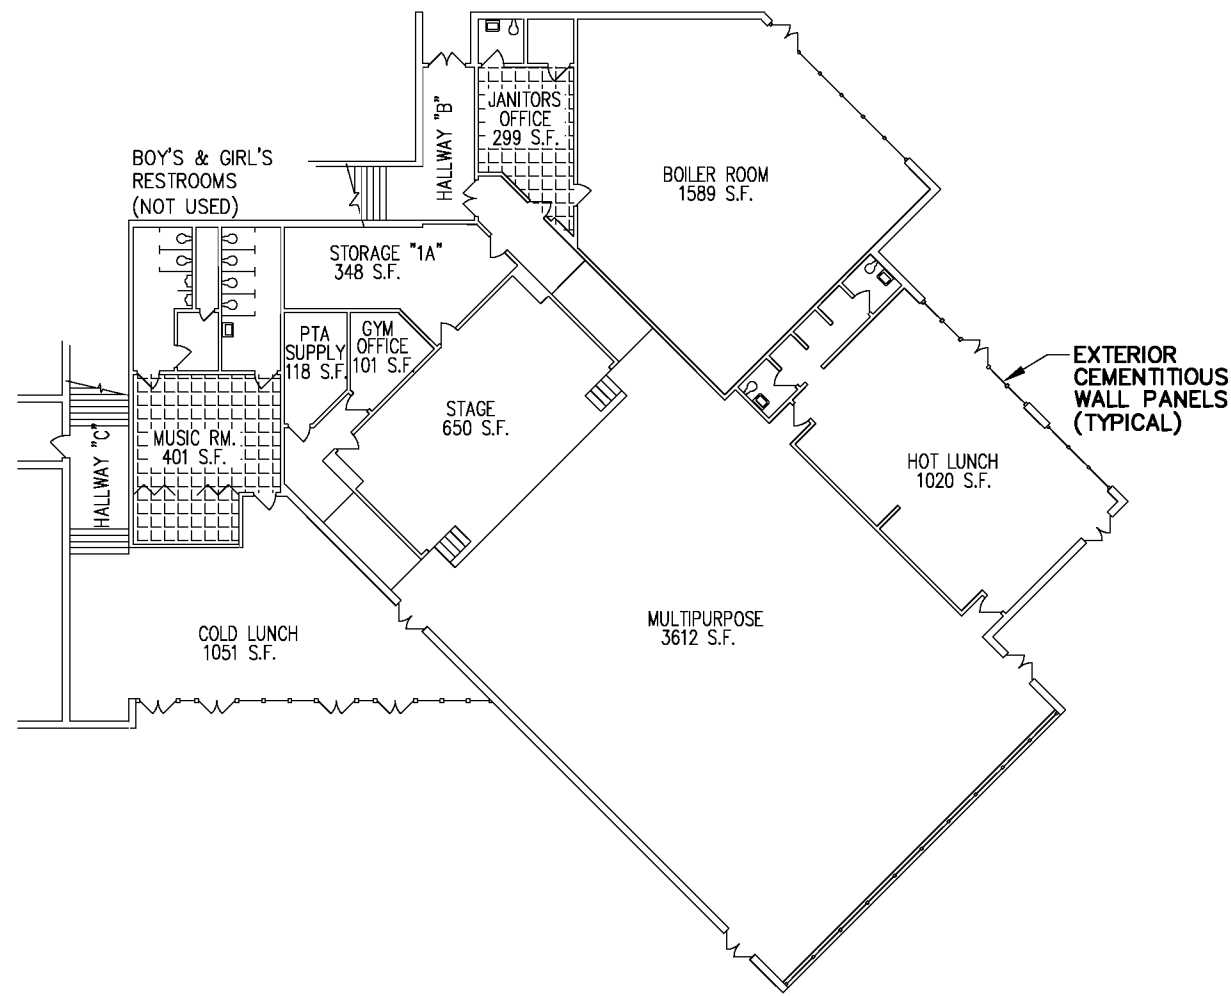
DRAWING No.:
A
6

12"x12" FLOOR TILE & MASTIC

ASSUMED ASBESTOS CONTAINING SURFACING MATERIALS:

1. CHALKBOARD MASTIC

2. DUCTWORK FLEX CONNECTIONS

3. BOILER GASKETS

4. VAPOR BARRIERS

5. EXTERIOR CEMENTITIOUS WALL PANELS
